## Smoke and Dye-Water Observation Summary

### Western Run Pilot Project - Baltimore Maryland

STREET: FIELDCREST RD. 198 A3	MAP #1: 1	MH: 1521325
CITY: BALTIMORE	MAP #2:	MH: 1521757
LOCALE: SMALL RESIDENTIAL STREET	TAPE #: JAM 1	TV'D LGTH: 47.19 ft

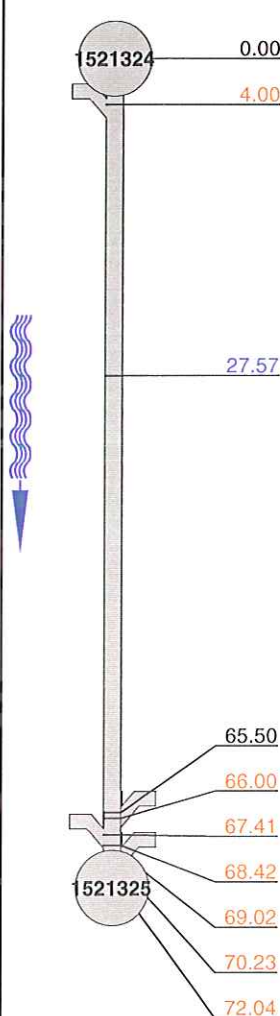
1:200	DIST	OBSERVATION	RATE	VCR #	PH

0.00	inspection begins at upstream manhole	0	01:23:33	
	4.00	service connection with roots heavy at 03 o'clock	3	01:23:14	88a, b
	27.57 S1	roots medium, START	2	01:25:41	90a
	65.50	service connection at 09 o'clock	0	01:27:38	
	66.00	roots heavy, from 12 to 12 o'clock	3	01:27:59	93a
	67.41	service connection with roots heavy at 03 o'clock	3	01:28:21	94a
	68.42	roots heavy, from 12 to 12 o'clock	3	01:28:47	95a
	69.02	service connection with roots heavy at 09 o'clock	3	01:29:09	96a, b
	70.23	roots heavy, from 12 to 12 o'clock	3	01:29:36	97a, b
	72.04	roots heavy, from 12 to 12 o'clock	3	01:30:57	98a
